## **Heavy rain causes overflow of POME from OPUL's Bbeta Mill**

## **PUBLIC STATEMENT**

18<sup>th</sup> MAY 2020

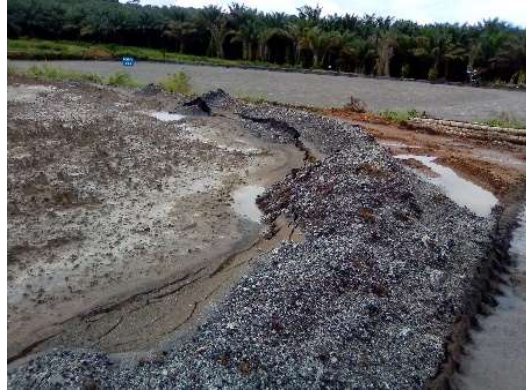
On Saturday, 9<sup>th</sup> May 2020, the effluent ponds of Bbeta Mill, of Oil Palm Uganda Limited (OPUL)<sup>1</sup>, overflowed due to uncharacteristic heavy rain locally, amounting to 310 mm in the first week of May. This amount of rainfall represents what is normally 20% of mean annual rainfall in the Kalangala district, where the mean monthly rainfall is usually 140 mm<sup>2</sup>.

Figure 2: Overflow of the POME treatment ponds

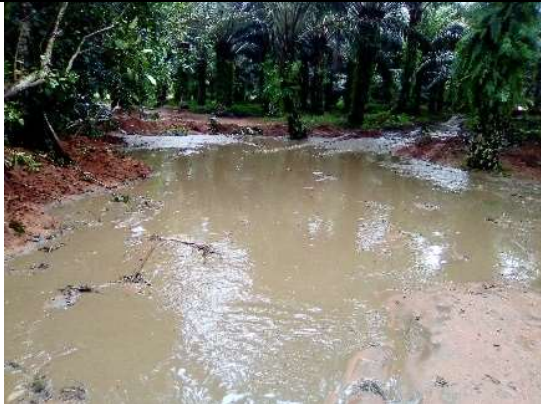
The overflow of palm oil mill effluent (POME) along with the heavy rain caused some localized flooding in the surrounding plantation estate, and also crossed into the neighbouring community. The POME and rain runoff has caused damage to OPUL's internal infrastructure, the connecting road, as well as to some community housing. Due to the location of the Bbeta Mill – which is on higher elevation – the overflow escaped into Kalangala Infrastructure (KIS) water pump, and subsequently into Lake Victoria.

Figure 3: Mixture of Rainwater & POME in OPUL plantation estate block

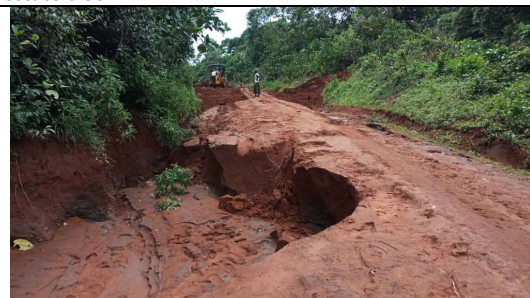
Figure 5: Damaged parts of the connecting road to the community due to overflow
